**Ottawa Light Rail Transit  
Project, Confederation Line**

**Investigation and Root Cause  
Analysis of June 8, 2016  
Sinkhole on Rideau Street**

**Report Status (Final Draft)  
Revision No. 2**

**December 22nd, 2016**

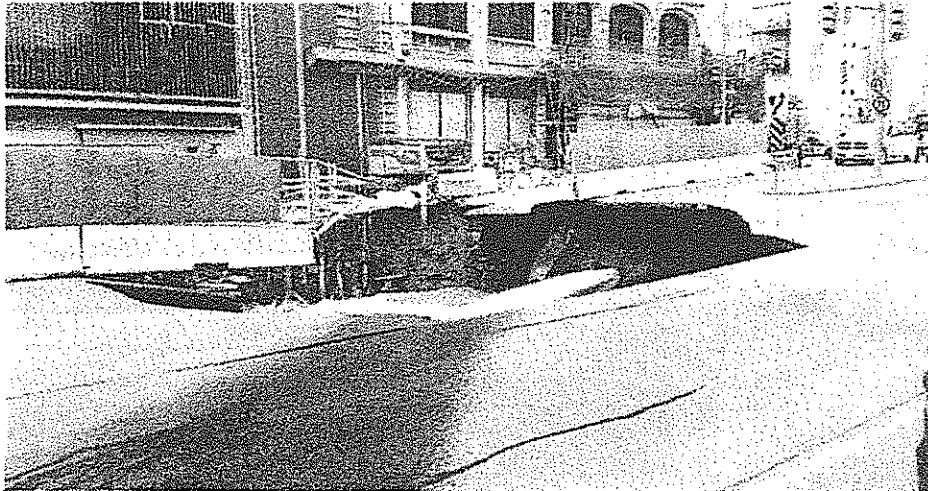
**Figure 1-1: Sinkhole on Rideau St. Looking SW at 10 Rideau St.**

- The surface manifestation of the sinkhole initiated on the south side of Rideau Street approximately 2 to 4 meters east of the west running tunnel face, and progressed to the north side of Rideau Street. The exact time of the initial surface manifestations of the sinkhole is uncertain based on available information, however by 10:30 to 10:35 AM the sinkhole had expanded across the southern half of Rideau Street. Refer to **Figure 1-1** and **Figure 1-2**.

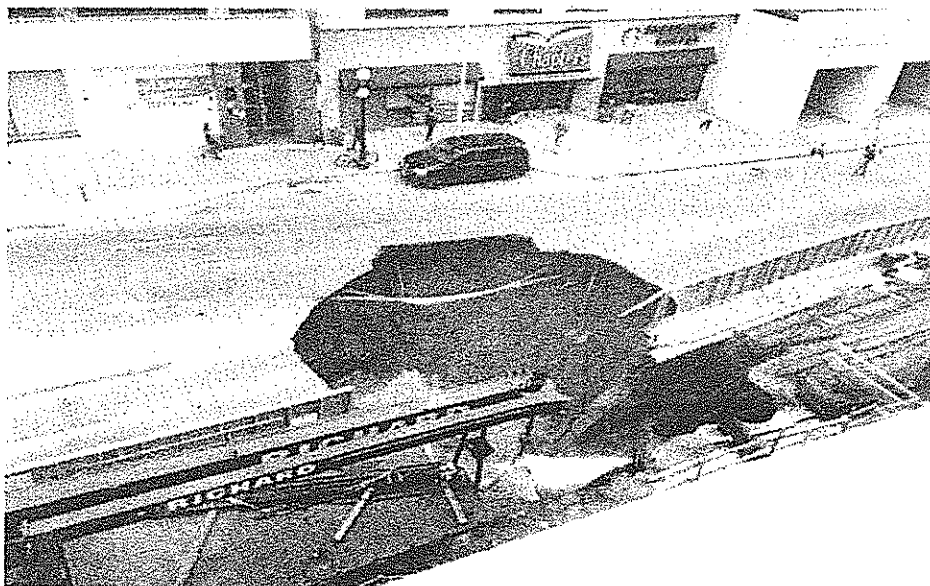
**Figure 1-2: Sinkhole on Rideau St. Looking North at 47-57 Rideau St**

- Failures of a 305 mm watermain located on the south side of Rideau Street and a 400 mm watermain located on the north side of Rideau Street occurred in connection with the sinkhole. The 305 mm watermain on the south side of the street failed prior to the 400 mm watermain which failed as a result of the sinkhole expanding to the north across Rideau Street

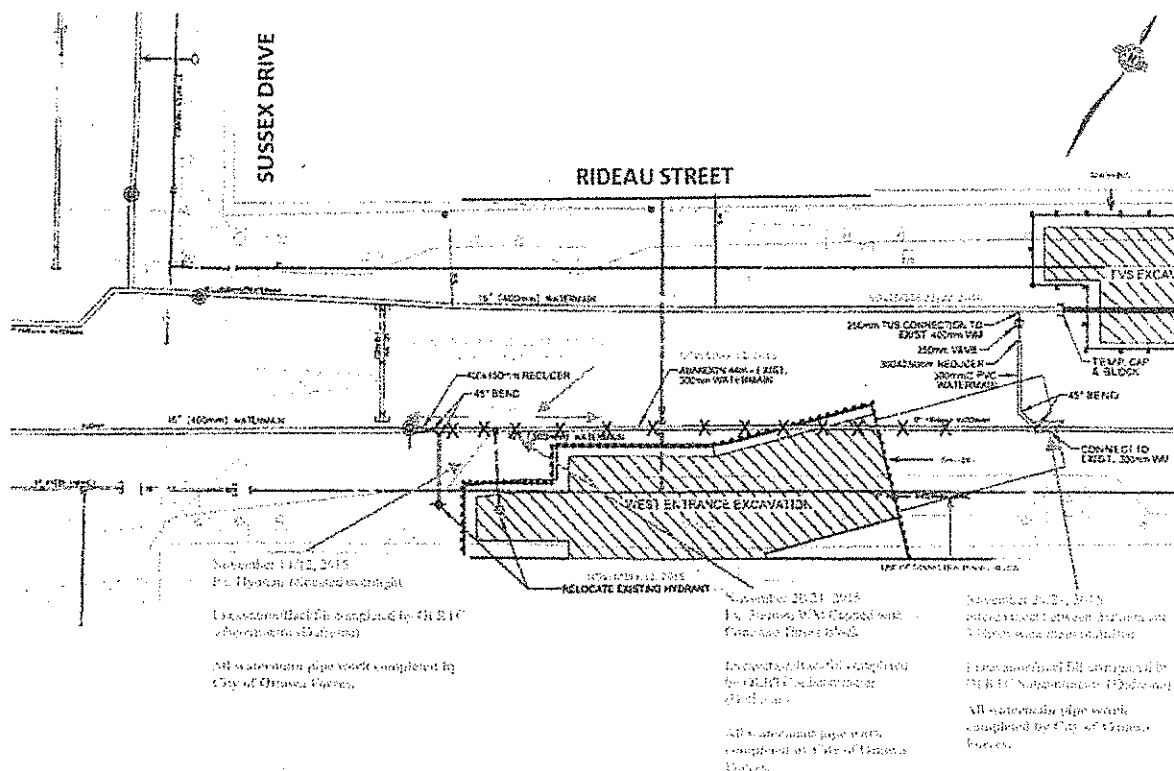
Figure 4-1: Rideau Street Watermain Modifications

Figure 4 is an excerpt from a drawing prepared by Robinson Consultants showing modifications to the 305 mm watermain in November 2015. These modifications include relocation of a fire hydrant at the west end of the Rideau Station West Entrance excavation, repair of a watermain break and construction of a cross-connection between the 305 mm watermain and the 400 mm watermain on the north side of Rideau Street to allow the portion of the 305 mm watermain within the Rideau Station West Entrance to be abandoned.

In addition to the modifications shown on Figure 4-1, it is understood that in early December 2015 OLRTC construction equipment struck the hydrant and caused it to leak and repairs were completed shortly thereafter. It is further understood that design and excavation and backfilling work required for the watermain modifications and repairs was the responsibility of OLRTC and that the work on the watermain itself required for the modifications and repairs was the responsibility of City staff.

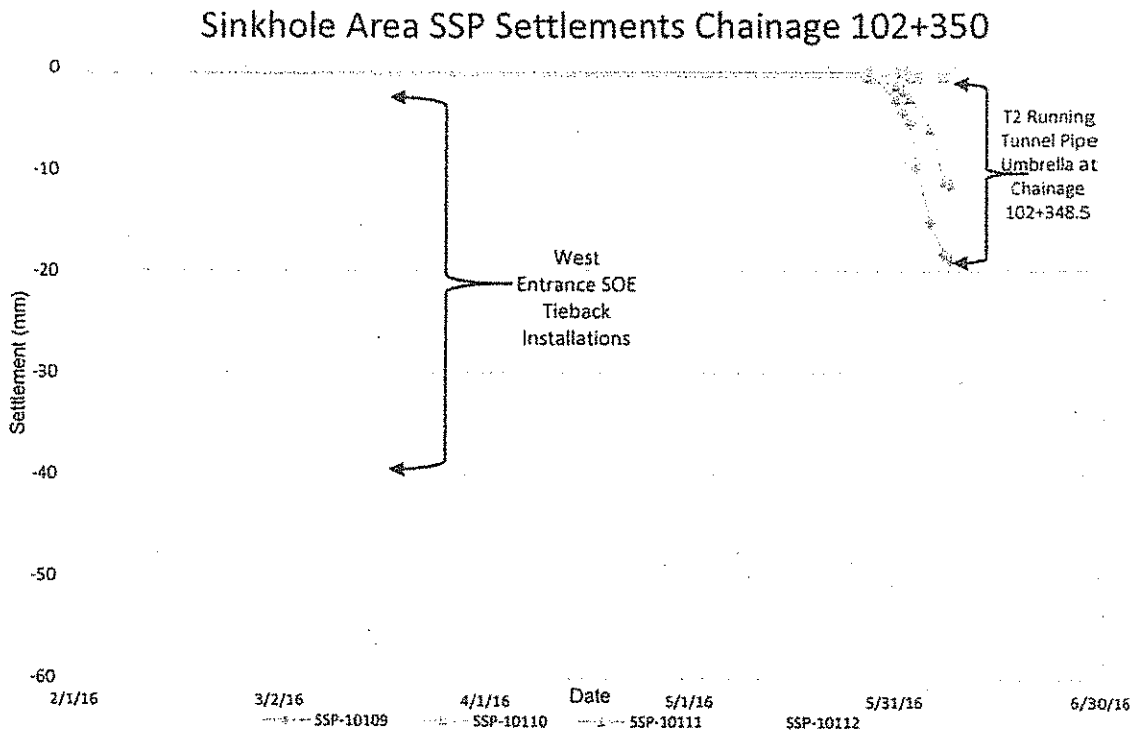
**Figure 7-1: Sinkhole Area SSP Settlements Chainage 102+350**

Of the 20 SSPs and two Extensometers monitored between Chainage 102+300 and 102+450, SSPs 10109-10112 were located near Chainage 102+350 and were destroyed as a result of the sinkhole. The two Extensometers survived the sinkhole event but were both removed by June 14 as a result of the repair and re-construction activities along Rideau Street. Figures 7-1 and 7-2 illustrate the measured settlements and the time rate of settlement increases typically associated with specific, or on-going, OLRTC activities within, or adjacent to, this portion of the running tunnel in the vicinity of the sinkhole.

Points 10109-10111 were initially installed and monitored since August 2015 while point 10112 was installed and monitored since February 2016. Point 10112 located close to the west end of the Rideau Station West Entrance excavation underwent approximately 40 mm settlement in the March 2016 time frame and then an additional 8 mm settlement by April 21. Between April 21 and June 8, SSP 10112 did not undergo any additional settlement. The nearly 50 mm settlement of SSP 10112 between mid-March and mid-April correlates with the time frame for the excavation and tieback installations for the West Entrance SOE.

It is noted that SSP 10110, located along the south side of Rideau Street, did not undergo any deformation over the 10-month period during which it was regularly monitored. This was a unique situation for any of the 20 SSPs monitored along the soil-filled valley section of the tunnel.

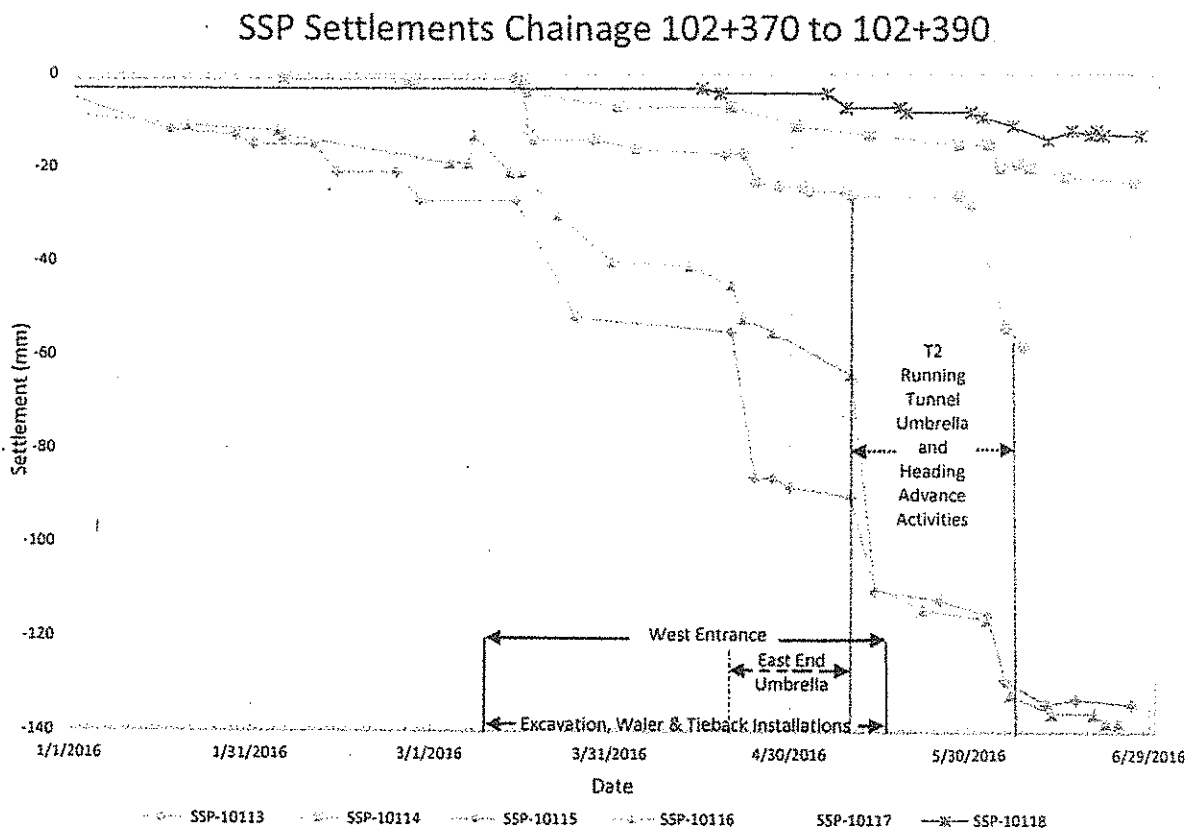
**Figure 7-2: SSP Settlements Chainage 102+370 to 102+390**

Further to the east, in the area of Chainage 102+370 to 102+375 (i.e. in proximity to the East Tunnel face, Chainage 102+403), there were two geotechnical instrumentation devices - SSP 10113 and Extensometer 40015. **Figure 7-2** illustrates that SSP 10113 showed a settlement increase of 10 mm in mid-March plus an additional 30 mm between May 31 and June 8. These settlements related to East Running Tunnel pipe umbrella installation and tunnel face advance activities. These increased settlements are demonstrative of the instability and erodibility of the saturated sandy glacial soils under a hydrostatic head when subjected to drilling and excavation activities related to pipe umbrella installation and tunnel advance.

The near surface anchor of Extensometer 40015 deflected 15 mm between March 15 and March 20 but no additional settlement was recorded between the end of May and June 8.

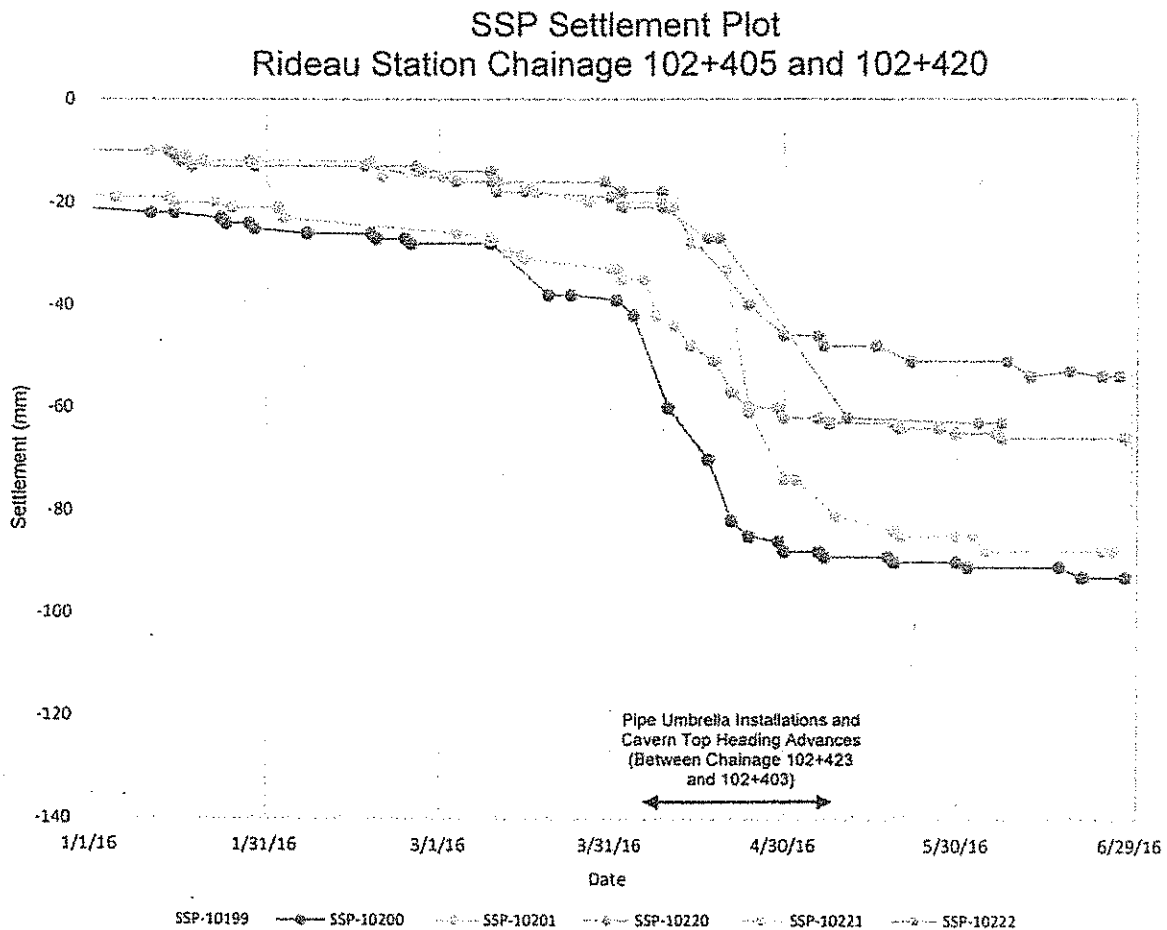
**Figure 7-3: SSP Settlement - Rideau Station Chainage 102+405 to 102+420**

Proceeding eastward, the remaining cross-sections evaluated for settlement increases were in the Rideau Station cavern between Chainage 102+405 and 102+420. At all locations, SSP settlement increases were associated with the respective time frames during which OLRTC was either installing pipe umbrellas or advancing the tunnel excavation. As an example, **Figure 7-3** illustrates the settlements recorded at SSPs 10199-10201 and 10220-10222 from the first part of April 2016 to the beginning of May 2016. As shown, these settlement increases are associated with pipe umbrella installations and Rideau Station top heading excavation advances from Chainage 102+423 to 102+403.

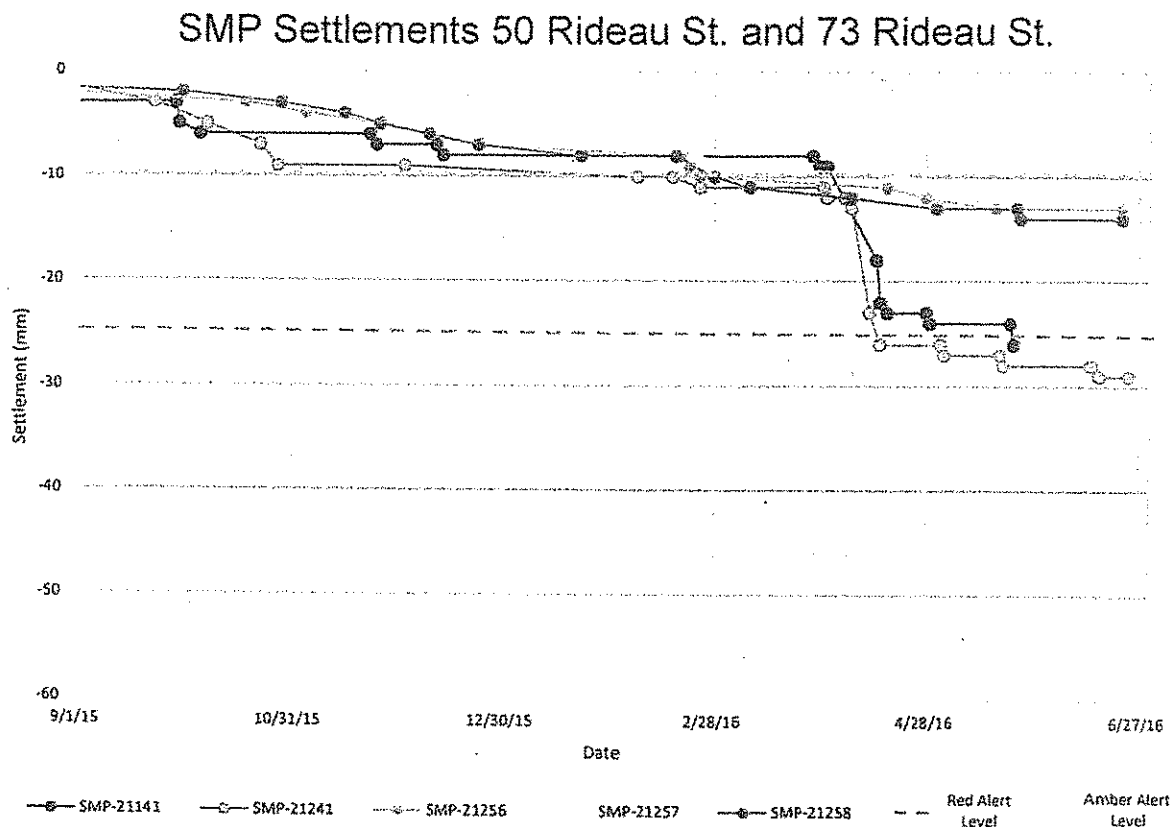
Figure 7-4: SMP Settlements – 50 Rideau St. and 73 Rideau St.

All four of the SMPs at 45 Rideau St and 47-57 Rideau St indicated 2 – 6 mm of additional settlement in the June 8 to June 11-time frame. Prior to June 8 and subsequent to June 11 all of the four SMP settlements were stable. As shown in Figure 7-4, there was no significant settlement effect on the SMPs at 73 Rideau Street (SMPs 21141 and 21241) prior to, during or after June 8.

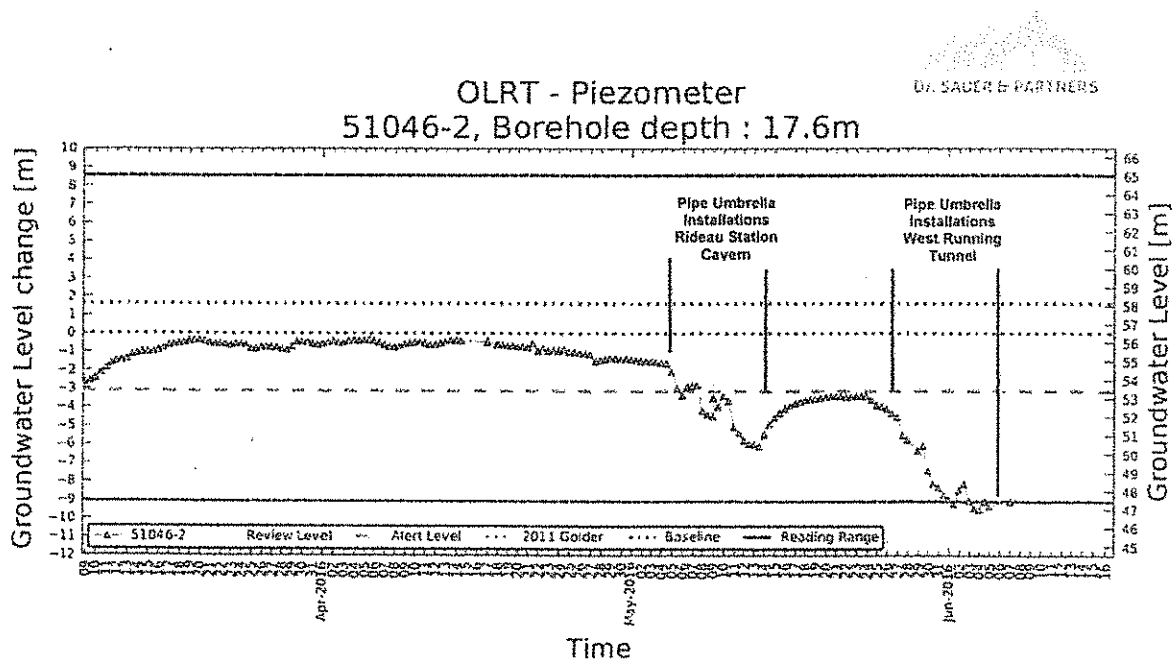
Figure 7-5: Piezometer 51046 Groundwater Level Readings- Chainage 102+360

Seven of the piezometers, with a total of 12 sensor levels, were located quite close to the sinkhole area along Rideau Street, including one of them (51046) that was destroyed by the sinkhole. The remaining six devices were located further to the north, south or east (well beyond the sinkhole). The three piezometers closest to the sinkhole, including 51046 as shown in Figure 7-5, experienced primarily steady or dropping groundwater levels in the days leading up to June 8. For example, piezometer 51046, located about 10 m to the east of the West Running Tunnel face on the day of the sinkhole exhibited an approximately 6 m drop in groundwater level during West Running Tunnel pipe umbrella installation. It should also be noted that water levels dropped in this piezometer during installation of a pipe arch umbrella for the Rideau Station cavern in early to mid-May 2016 and that water levels recovered somewhat after completion of that pipe umbrella.

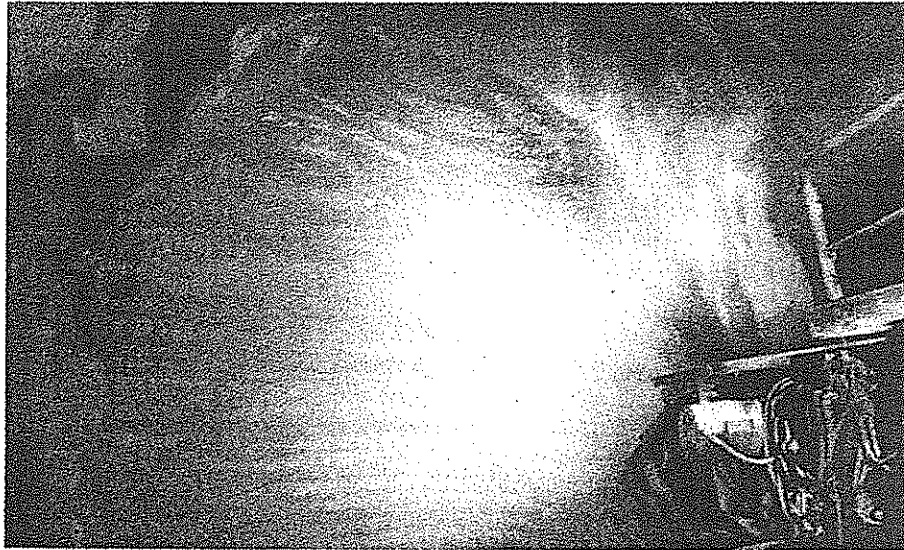
**Figure 9-1: Chainage 102+349.5 Bedrock Heading Photo (June 8th 2016 at 8AM)**

- The sinkhole was associated with the collapse of the face of the west running tunnel. It is significant to note that **Figure 9-1** taken at approximately 8 AM on June 8, illustrates what appears to still be a full face of bedrock in the West Running Tunnel face in vicinity of Chainage 102+349.5. As shown in **Figure 9-2**, at the time of the collapse the west running tunnel face was at approximately Chainage 102+ 350 in so-called mixed-face conditions, meaning that there was both soil (soft ground) and bedrock present in the face, with the soil present on the south side of the face. The collapse appears to have started in the 10:15 – 10:30 AM time frame, when it became apparent to the personnel at the tunnel face that a combination of high water flows and ground instability at the tunnel face was serious enough to mandate their quick evacuation of the heading.

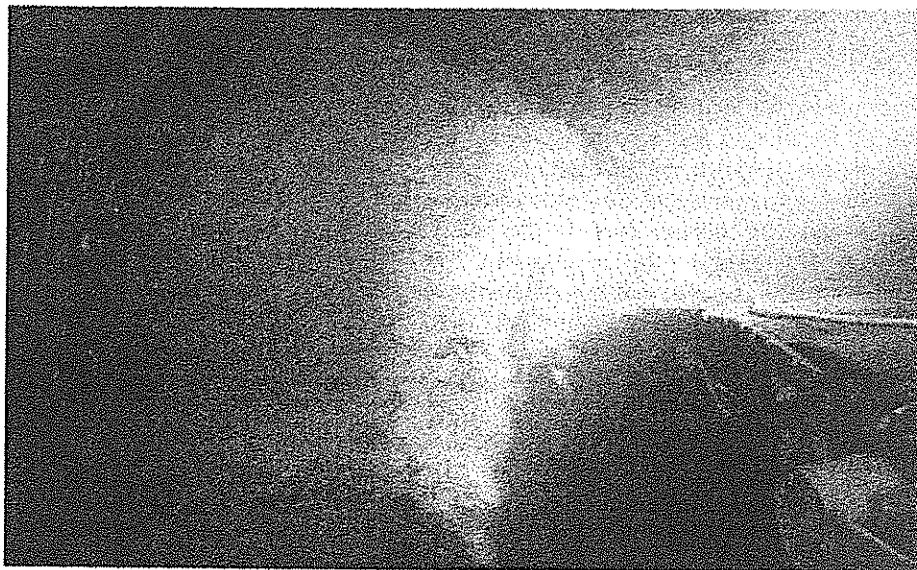
**Figure 9-2: Chainage 102+350 Bedrock and Soft Ground Heading Photo (June 8, 2016 at approximately 10:20 AM, prior to time of complete face collapse)**

The available information and observations indicate that it is highly likely that the root cause of the sinkhole was instability of the saturated sandy soil under approximately 4 meters of groundwater pressure on the south side of the west running tunnel face near Chainage 102+350 which in turn lead to loss of ground up through the soil profile. This loss of ground likely occurred very rapidly because the ground had previously been disturbed and loosened in response to pipe umbrella installation and the West Rideau Station Entrance excavation. This loss of ground then likely resulted in loss of support for the 305 mm watermain on the south side of Rideau Street and its subsequent catastrophic rupture. Water flowing from this rupture then caused erosion of the loosened, sandy soils below the watermain and the flow of a vast amount of soil into the west running tunnel, thereby creating the large sinkhole.

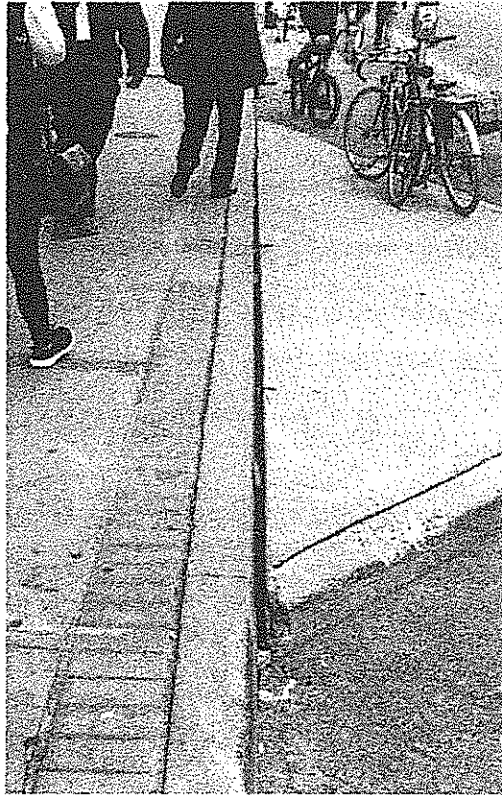
**Figure 9-3:47-57 Rideau Street Sidewalk/Curb Separation**  
Photo (June 6, 2016)

- Settlement of the ground surface above the West Running Tunnel pipe umbrella at Chainage 102+348.5 occurred during pipe umbrella installation (i.e. during the period from May 26<sup>th</sup> to June 7<sup>th</sup> 2016). Where it was measured at settlement monitoring points located directly above the tunnel face, the magnitude of ground surface settlement ranged up to approximately 20 mm. There were no settlement monitoring points within 25 m east of the tunnel face, however ground surface settlement would be anticipated to be greater than 20 mm east of the tunnel face in the zone of pipe umbrella installation. This conclusion is supported by the observation that ground surface settlement was observed to manifest itself in opening of joints and pre-existing cracks in the sidewalk on the north side of Rideau Street adjacent to the zone of pipe umbrella installation, as seen in **Figure 9-3**. There were no such observations on the south side of Rideau Street because the

sidewalks there had been displaced by the excavation for the West Rideau Station entrance. This ground surface settlement is likely related to loss of ground during installation of the pipe umbrella. A similar relationship between pipe umbrella installation and surface settlement was observed in connection with pipe umbrella installation for the Rideau Station located to the east of the sinkhole.

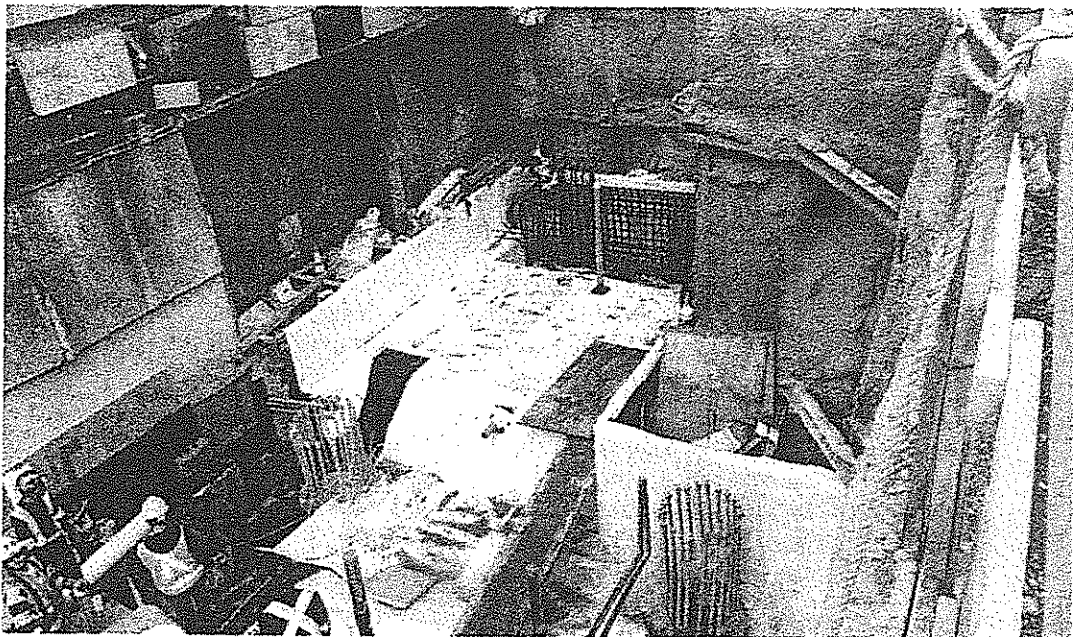
**Figure 9-4: West Entrance (West End) Conditions on June 8, 2016 at 8AM (prior to sinkhole)**

- There was no observed increase in groundwater levels prior to June 8th, 2016 as would be expected if significant leakage from either watermain was occurring. Such an increase in groundwater levels was observed in connection with a leak that occurred in the 305 mm watermain in mid- November 2015. In fact, groundwater levels in the vicinity of the sinkhole dropped on the order of 6 meters in response to west running tunnel construction activity in the days leading up to the sinkhole.
- As shown in **Figure 9-4**, there was no observed significant leakage of water into the Rideau Station West Entrance as would be expected if the adjacent 305 mm watermain on the south side of Rideau Street had significant leakage.
