Fluvial Geomorphology Report

City of Ottawa

East LRT Planning and Environmental
Assessment – Fluvial Geomorphology
Report

July, 2015

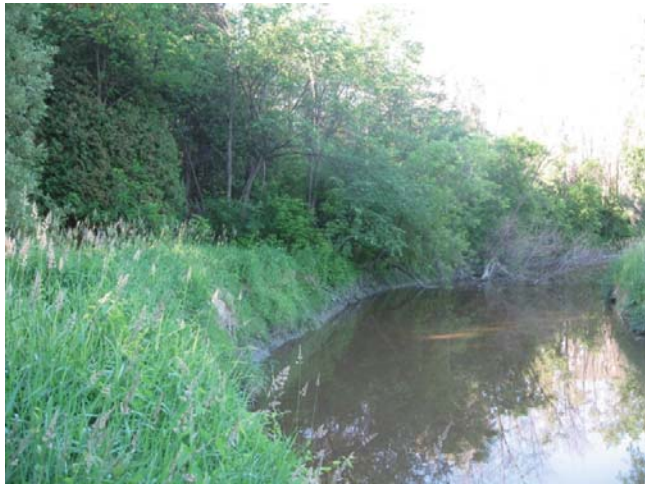
Photograph 1. ↑
Looking upstream, upstream of crossing

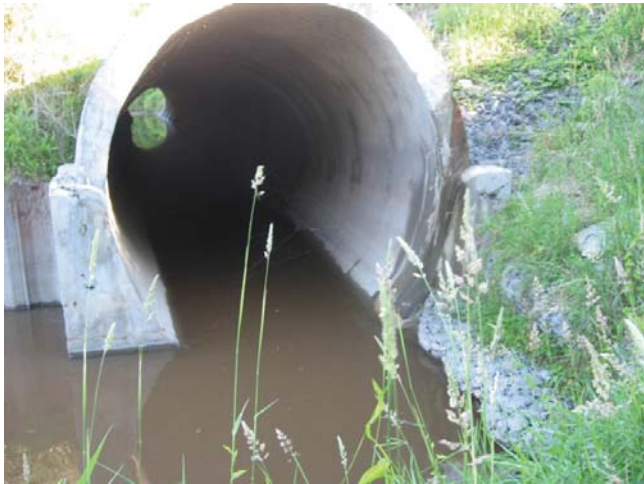
Photograph 2. ↑
Looking downstream through most eastern culvert

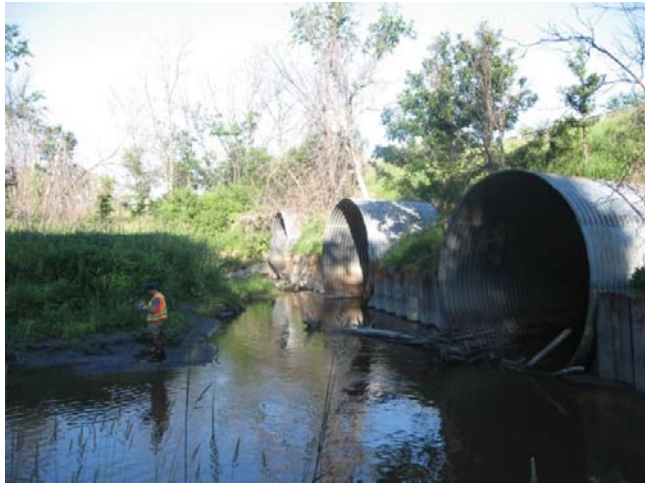
Photograph 3. ↑
Left bank and inlet

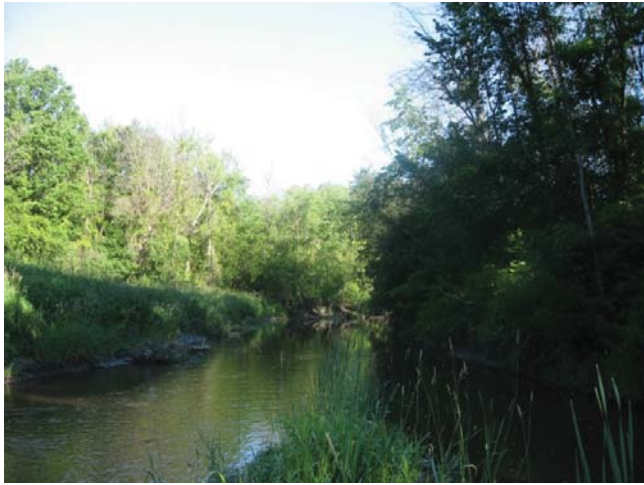
Photograph 4. ↑
Looking downstream from outlet

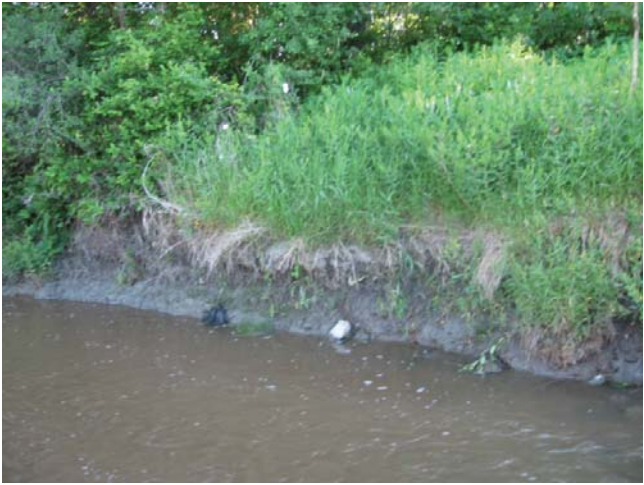
Photograph 5. ↑
Looking at exposed till on right bank, downstream of crossing

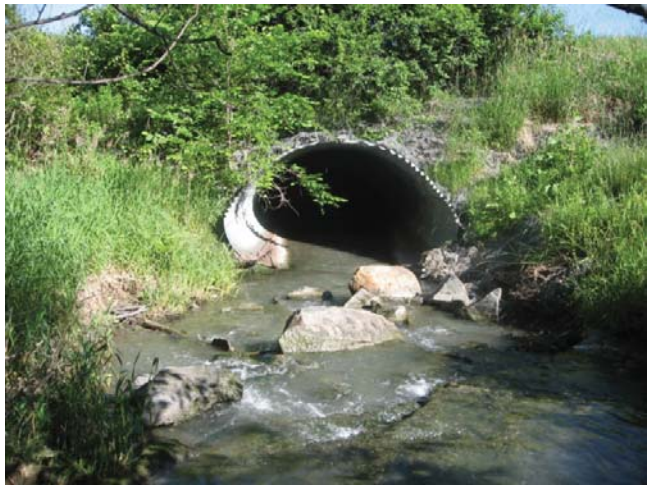
Photograph 7. ↑
Inlet

- Failed gabion on right bank at inlet
- Entrenched drainage channel confluences with main channel immediately upstream of culvert
- Failed gabion on both banks at outlet
- Failed gabion material has accumulated ~20 m downstream of the outlet
 - Multiple channels have formed
 - Diverting flows in the left bank valley wall causing excess scour
- Cut-off channels have formed at the meander upstream of the crossing
- Downstream of the crossing the channel is very incised and unstable
 - Consider removing failed engineering material (gabion, rip rap) and applying principles of natural channel design

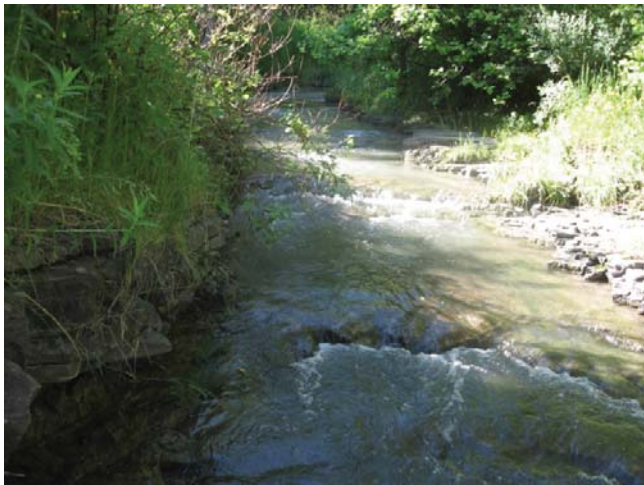
Bedrock is exposed along the channel in the vicinity of the Ottawa Road 174 crossing. Here, bed and banks are lined with riprap as erosion protection. Basal scour in unprotected stream bed and a knickpoint in the bedrock section show downcutting. Eroding cutbanks bordering private property are also present in this reach. Downstream of the highway, the watercourse is more sinuous. Bank slumping and slope failure are prominent erosive features identified within the study area both upstream and downstream of the highway. Further downstream, the gabion baskets have been applied to protect stream banks. Erosion protection (i.e., rip rap, gabion baskets, crib walls) installed within the study area and greater subwatershed appeared to be functioning as intended (Geomorphic Solutions, 2007). RVCA (2009) classified approximately 45% of the watercourse banks as “unstable”.

Photograph 8. ↑
Looking upstream at bedrock channel from inlet

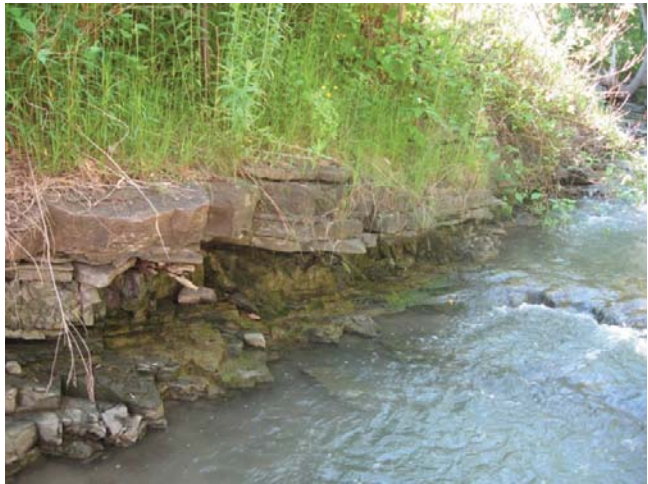
Photograph 9. ↑
Left bank, upstream of crossing

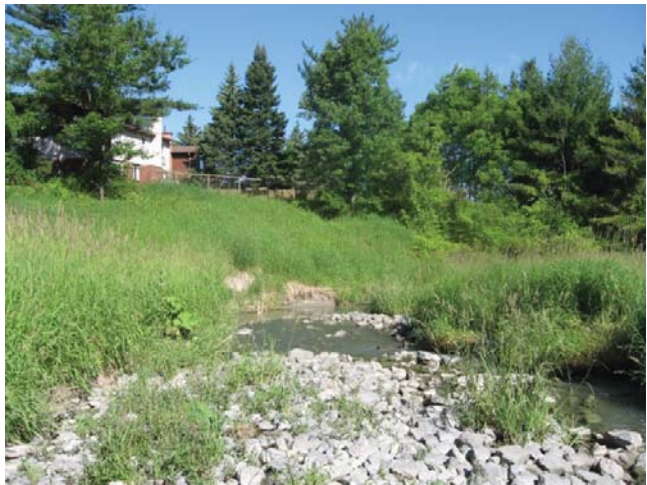
Photograph 11. ↑
Looking downstream from outlet

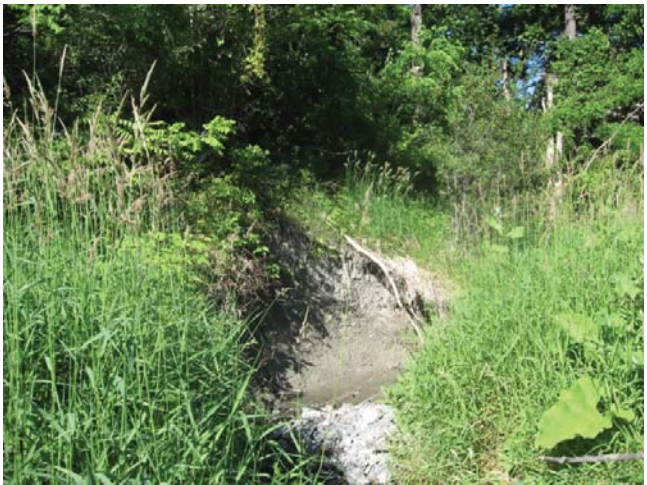
Results of the RGA at Bilberry Creek are presented in Table 6-6. The dominant morphological process upstream of the crossing is degradation as the channel has worn into bedrock. Downstream of the crossing, the channel is undergoing planform adjustment and degradation which is likely attributed to higher peak flows as a result of upstream development (two significant stormwater outlet were observed near the crossing). As well, failed gabion baskets and the subsequent deposition of the gabion material downstream of the outlet has caused multiple channels to form and has led to excess bed and bank erosion.

Photograph 12. ↑
Scour on left bank, downstream of crossing

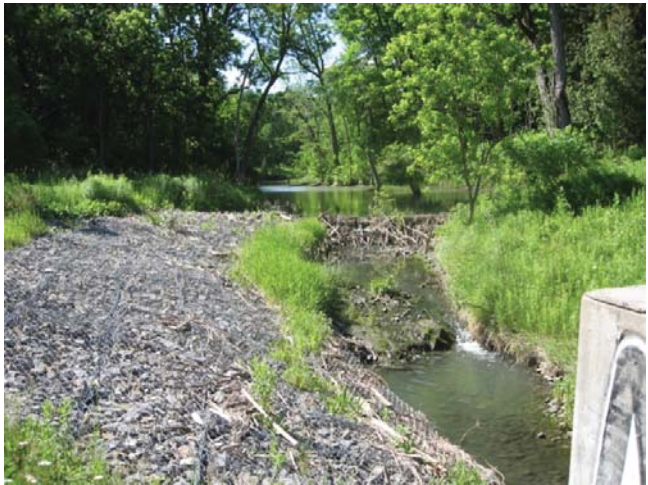
Taylor Creek is a meandering channel within a defined valley system. Approximately 20 m upstream of the crossing a beaver dam has caused backwater conditions to form and has disrupted sediment and debris transport. Review of ortho-imagery suggests the dam is less than 2 years old. Downstream the channel is actively scouring the bed and bank. A photographic record of Taylor Creek and the Highway 174 crossing can be observed in **Appendix A**.

- The beaver dam is disrupting natural sediment transport dynamics
- A dam failure or breach would result in a large release of water, debris, and sediment
- Gabion basket on the right bank at inlet has failed and material has accumulated in culvert
- Gabion baskets downstream of outlet have failed material has accumulated ~10 m downstream
 - Multiple channels have formed
 - Diverting flows causing excess bank and bed scour
- Meanders downstream of the outlet are unstable
- Downstream of the crossing the channel is very incised and unstable
 - Consider removing failed engineering material (gabion, rip rap) and applying principles of natural channel design

Photograph 14. ↑
Looking upstream at beaver dam from inlet

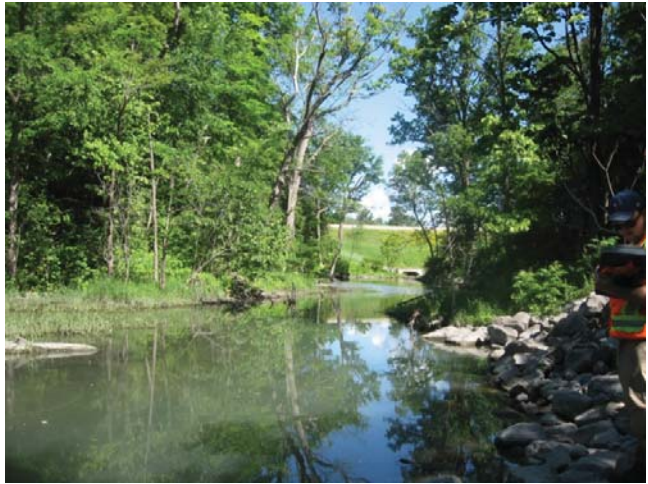
Photograph 15. ↑
Looking downstream, upstream of crossing

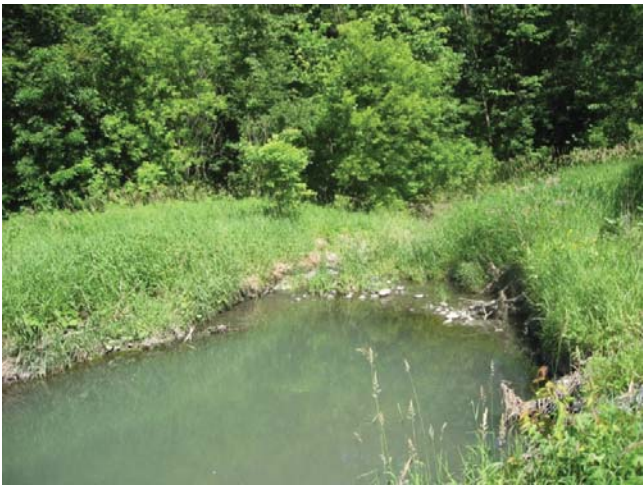
Photograph 17. ↑
Looking downstream from outlet

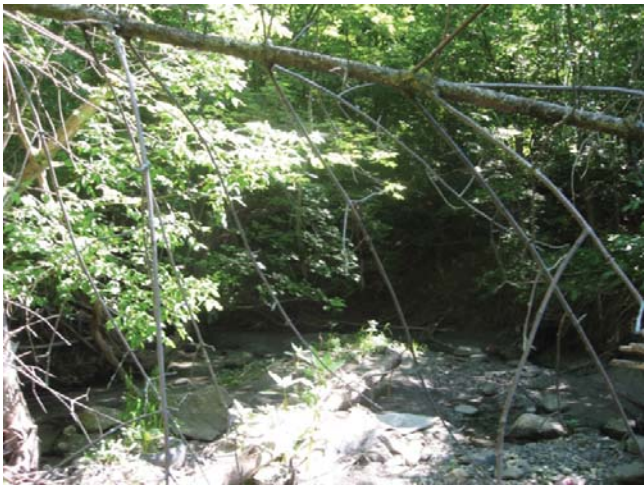
Results of the RGA at Taylor Creek are presented in Table 6-9. The dominant morphological process upstream of the crossing is aggradation as backwater conditions has led to sediment deposition and an overall increase in bed elevation. Downstream of the crossing, the channel is undergoing planform adjustment which is likely attributed to higher peak flows as a result of upstream development. As well, similar to Bilberry Creek, failed gabion baskets and the subsequent deposition of the material downstream of the outlet has caused multiple channels to form and has led to excess bed and bank erosion.

Photograph 18. ↑
Looking downstream at bed and bank scour, downstream of crossing
