**Ottawa Light Rail Transit  
Project, Confederation Line**

**Investigation and Root Cause  
Analysis of June 8, 2016  
Sinkhole on Rideau Street**

**Report Status (Final Draft)  
Revision No. 2**

**December 22nd, 2016**

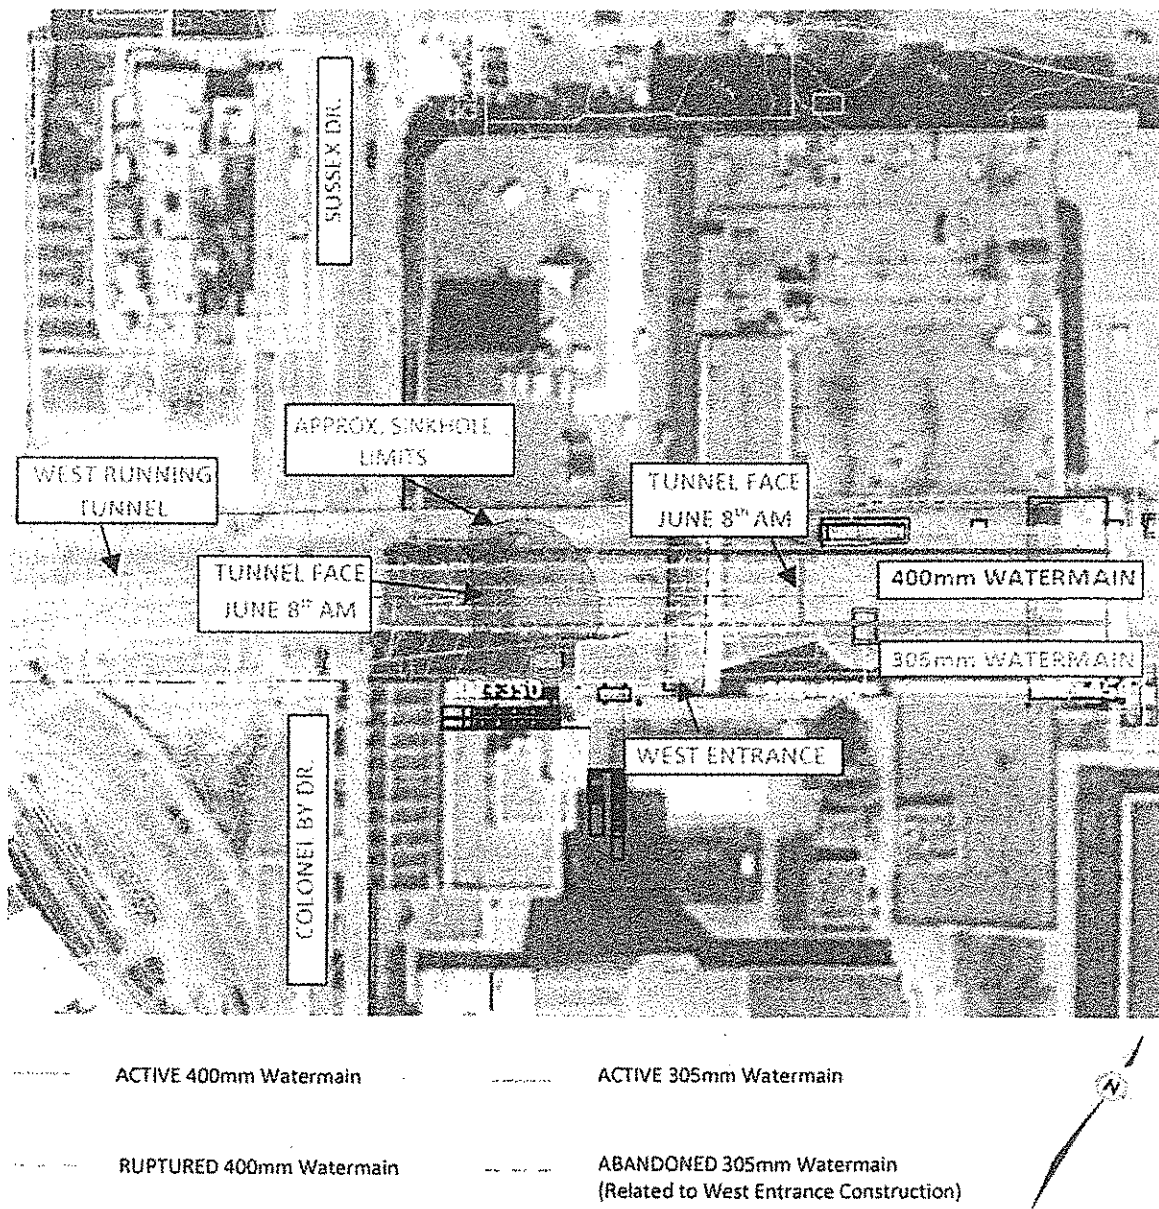
Figure 1-3: Rideau St. Sinkhole Area Plan View

**Figure 1-3** is the plan area of the Rideau Street sinkhole including area streets, buildings, the running tunnel and Rideau Station alignments, watermain, and sinkhole limits

- Two City of Ottawa water mains (305 mm diameter ductile iron pipe (DIP)/PVC and 400 mm diameter PVC pipe) (Refer to Figure 1-3)
- One City of Ottawa lateral water main with a flexible expansion coupling connection at 41 Rideau Street,
- One City of Ottawa 600/750 mm diameter concrete storm sewer,
- One City of Ottawa 375 mm diameter concrete sanitary sewer,
- One Enbridge 100 mm diameter polyethylene gas line,
- One Hydro Ottawa concrete-encased electrical duct bank,
- One Bell concrete-encased communications cable duct bank.

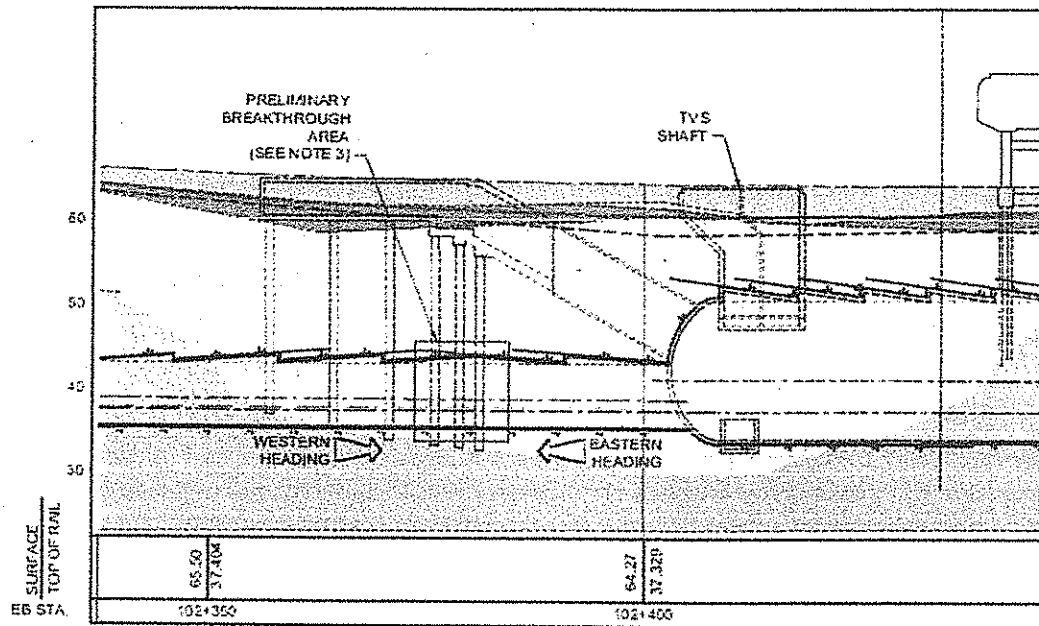
Figure 5-1: Temporary Support Profile for Glacial Valley Soft Ground Conditions

OLRTC had developed and employed several construction approaches originally established for the sections of the tunnel advanced primarily through bedrock from the West Portal and East Portal. Then, related to having to manage greater settlements and other risks in the portion of the tunnel alignment through the soil-filled glacial valley additional measures were initiated. These included modifications to excavation support requirements related to the SEM tunnel advance in soil as shown in **Figure 5-1**. OLRTC's original

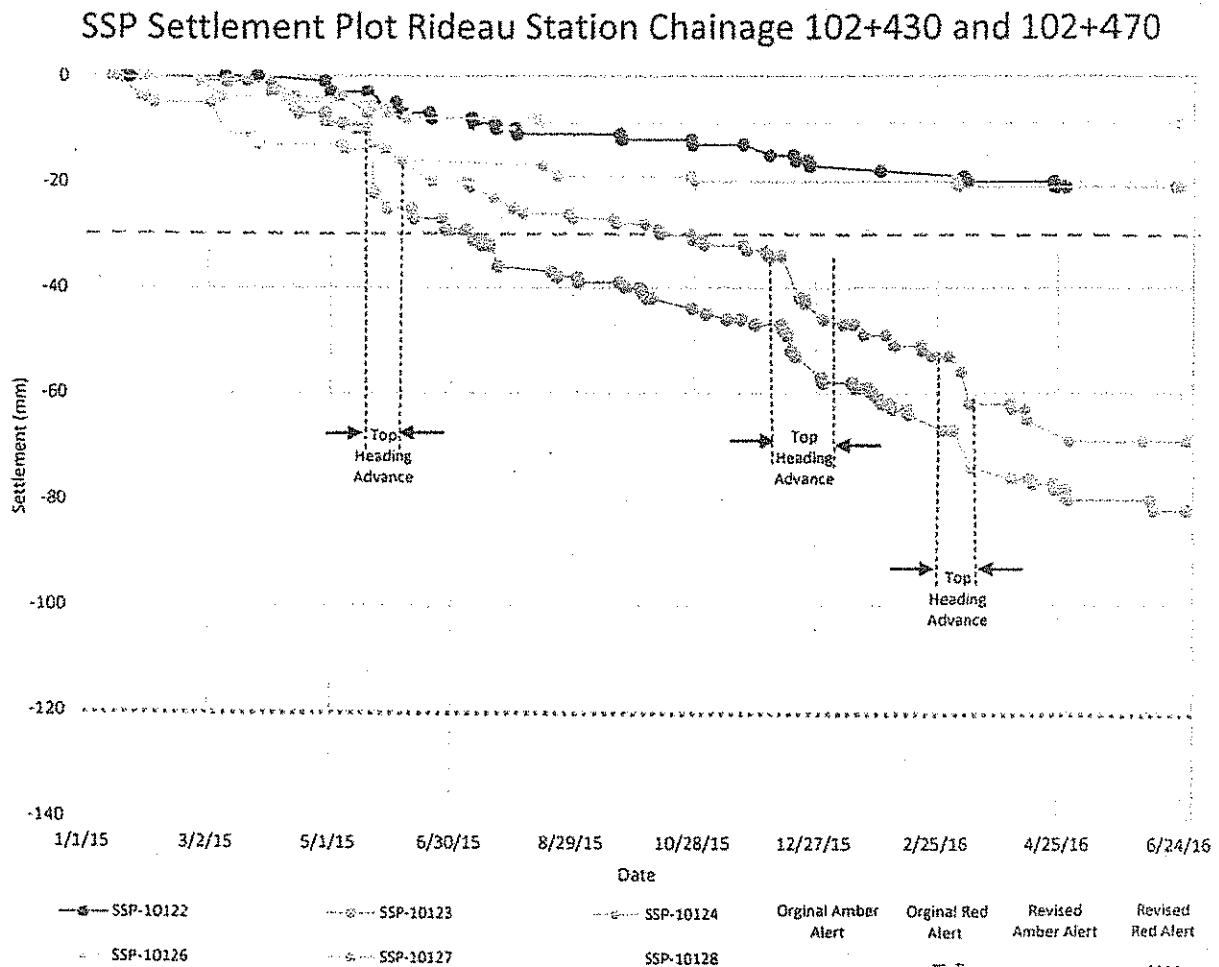
**Figure 5-2: SSP Settlements – Rideau Station SSP Settlements and Alert Levels**

In 2014, trigger levels for these SSPs, were originally set at 10 mm for an amber alert level (i.e., intermediate level) and 25 mm for a red alert level (highest level). Then in April 2016 those alert levels were revised upward for many of the SSPs in the Rideau Station soil-filled valley area (approximately Chainage 102+330 to 102+450). Figure 5-2 shows an example of the original and revised alert level settlement limits along with measured settlements that typically increased as a result of OLRTC excavation and ground support activities in the Rideau Station Cavern. Refer to Attachment 6, DSP-86-2-RISU-MEM-0006-Rev 1 for an explanation of trigger level revisions in Rideau Station.
